Course Update

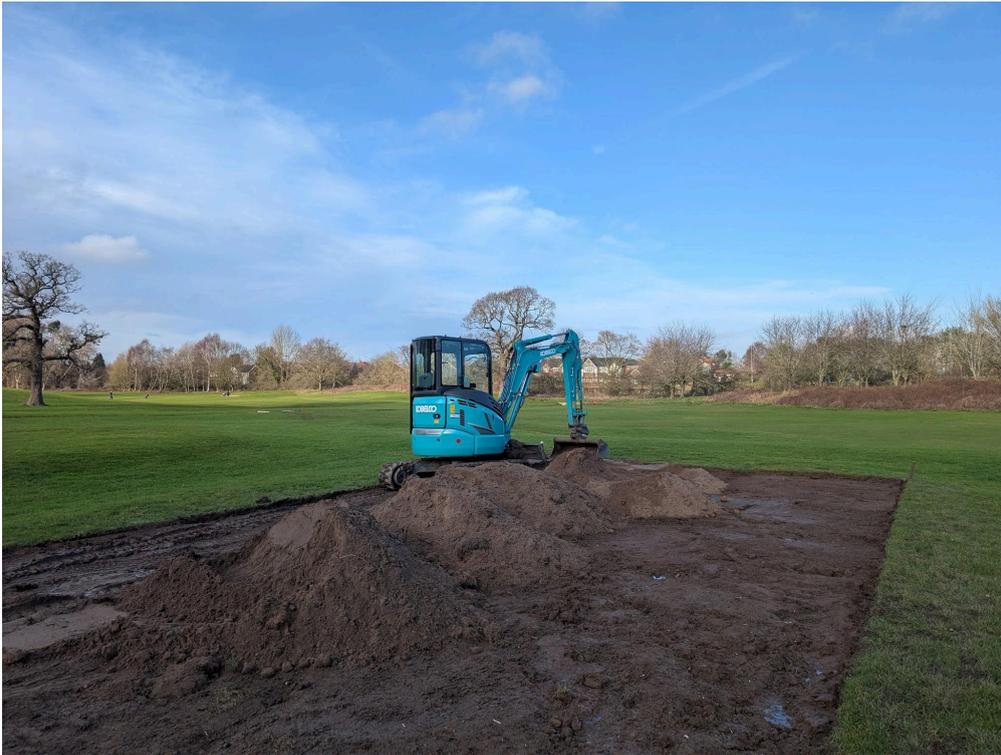
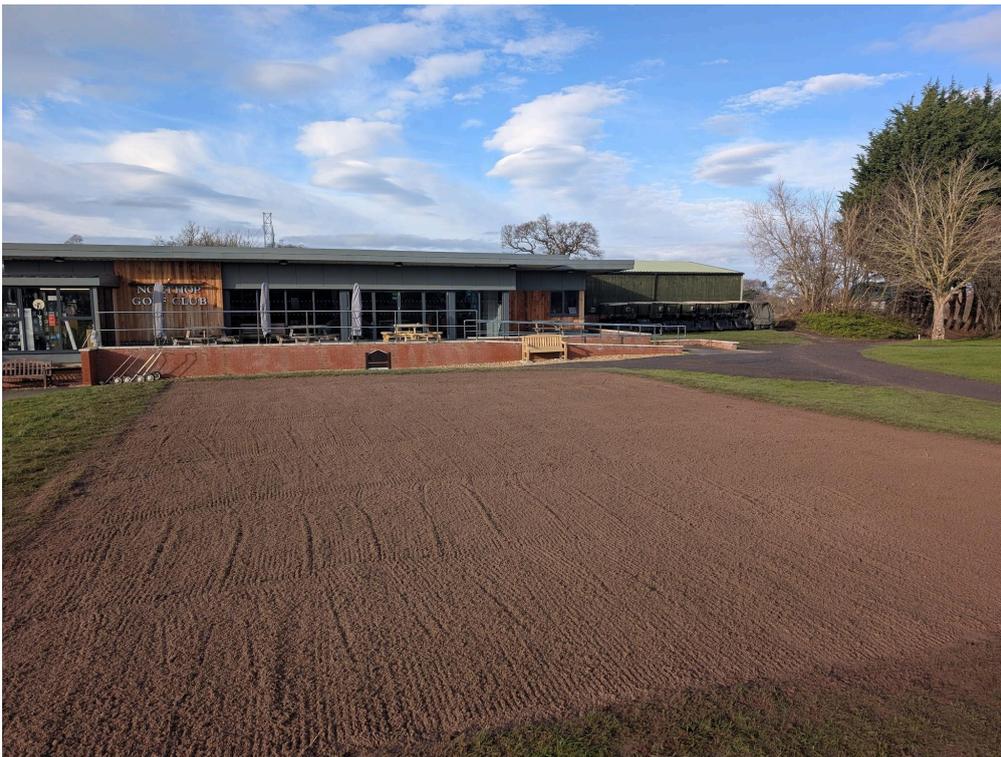
Yellow tees hole 1 & 2 - Turf stripped, 70/30 rootzone added and levelled and prepped awaiting turf.

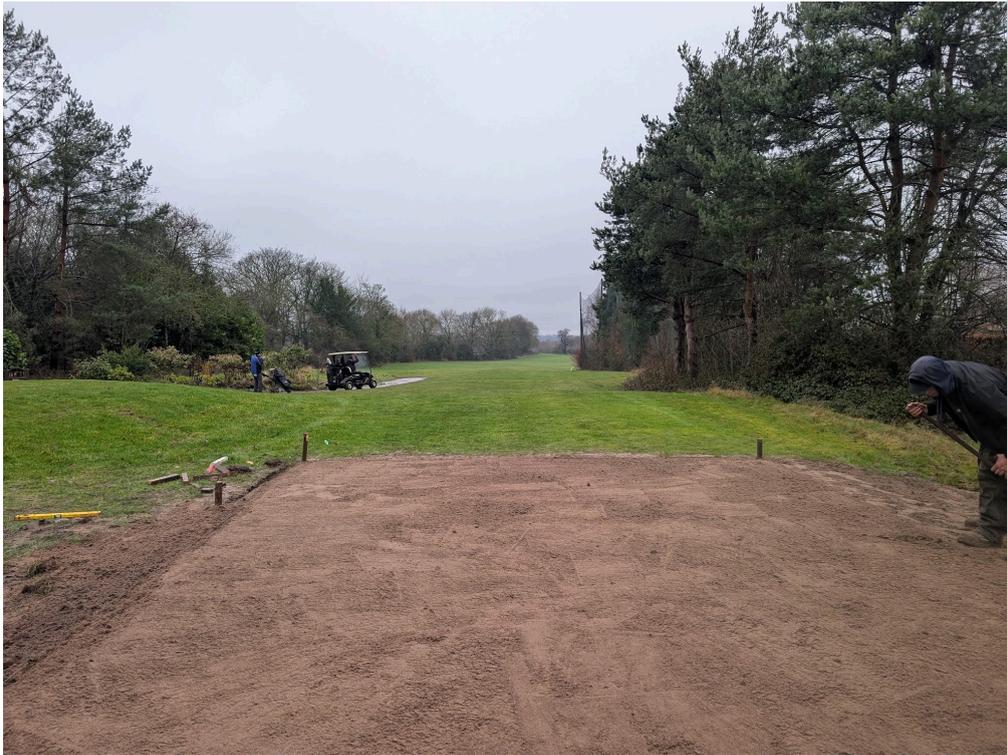
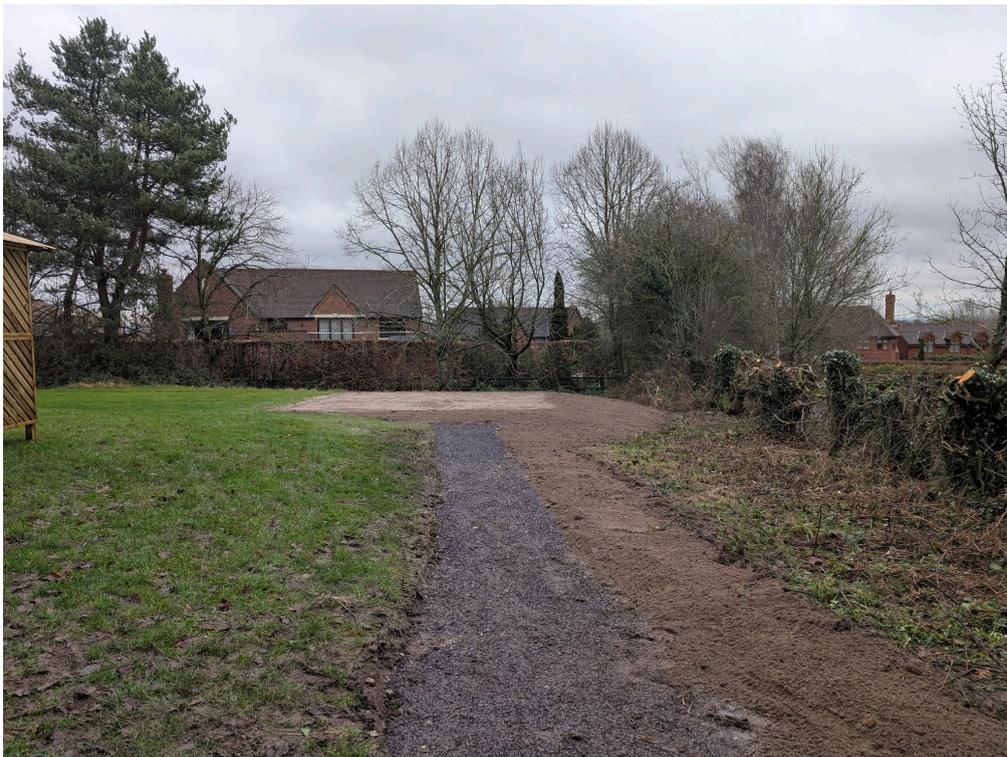
White tee 16 - extended by 15 yards, rootzone added, levelled, path reinstated and awaiting turf. This extension will increase the playing length of the hole while also bringing the net more into play, helping to deflect errant tee shots away from nearby houses.

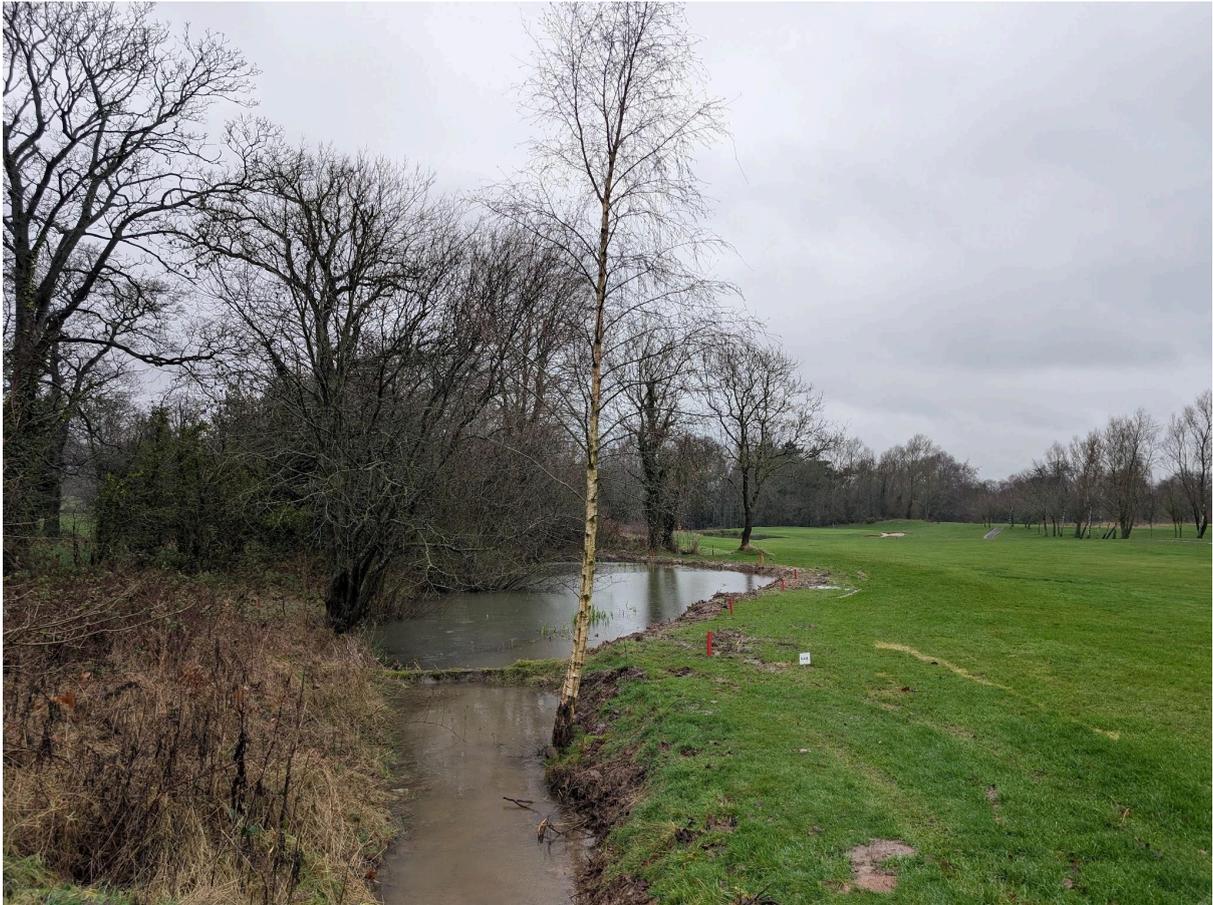
Dew pond - hole 16 has been cleared of vegetation, including the ditch leading into it. The ditch has been deepened and has intercepted a natural spring that may previously have been bypassing the channel and running onto the fairway. An additional overflow has also been installed from the pond to prevent water escaping.

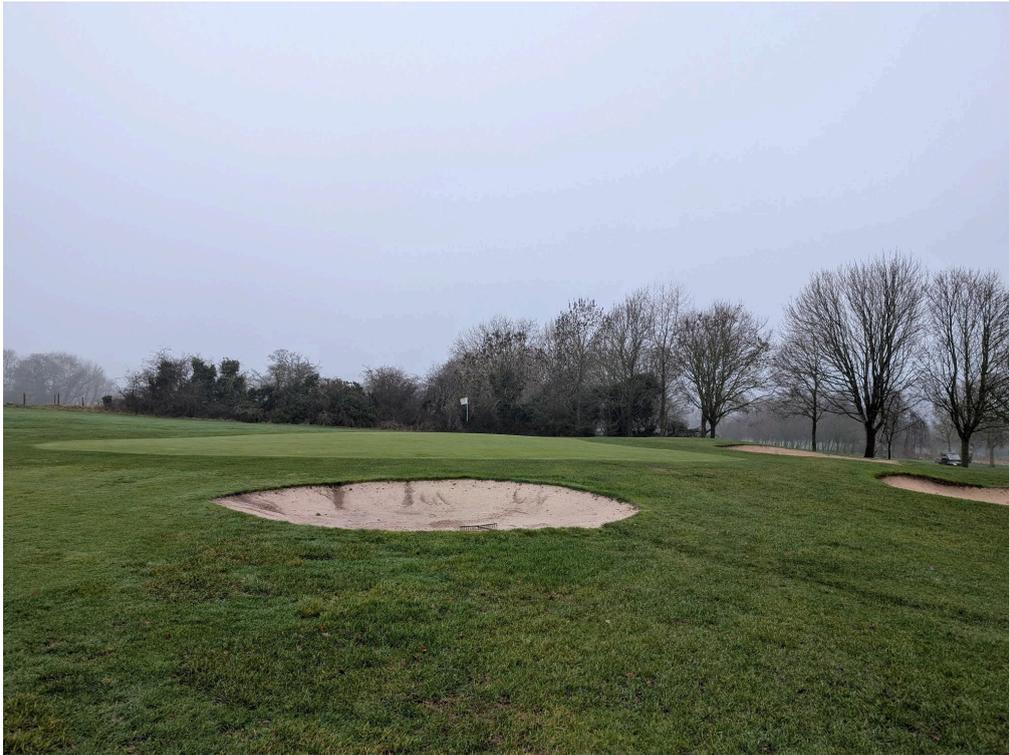
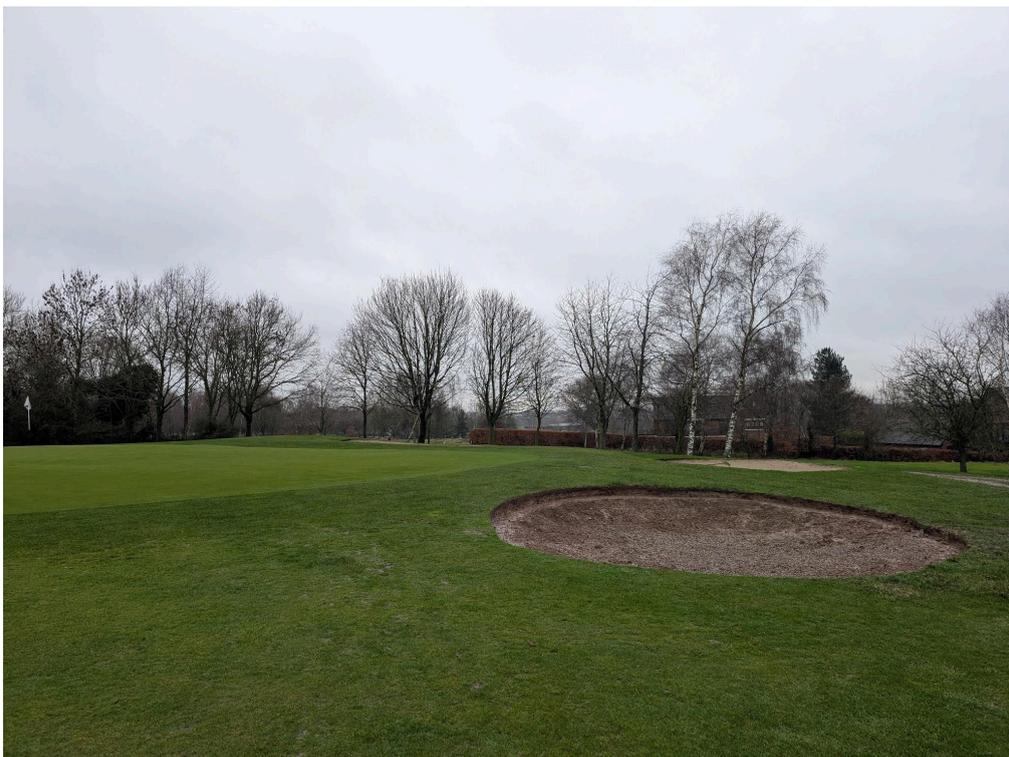
Greenside Bunker - Hole 16 - The bunker was previously too shallow with minimal edging. Observations showed that low-running approach shots were not being retained, with golf balls frequently running through the bunker. High winds were also causing significant sand drift. The bunker has been excavated to a depth of approximately 3 feet, will be lined (grass liner), and finished with a revetted edge.
